Subject: Site Screening Inspection, Phase II  
Evans Property Sludge Site  
Melbourne, Brevard County, Florida  
TDD No. F4-8911-24  
EPA ID No. FLD980556500

## HAZARD RANKING SYSTEM SCORING SUMMARY

EVAN'S PROPERTY SLUDGE SITE  
EPA SITE NUMBER FLD980556500  
MELBOURNE  
BREVARD COUNTY, FL  
EPA REGION: 4

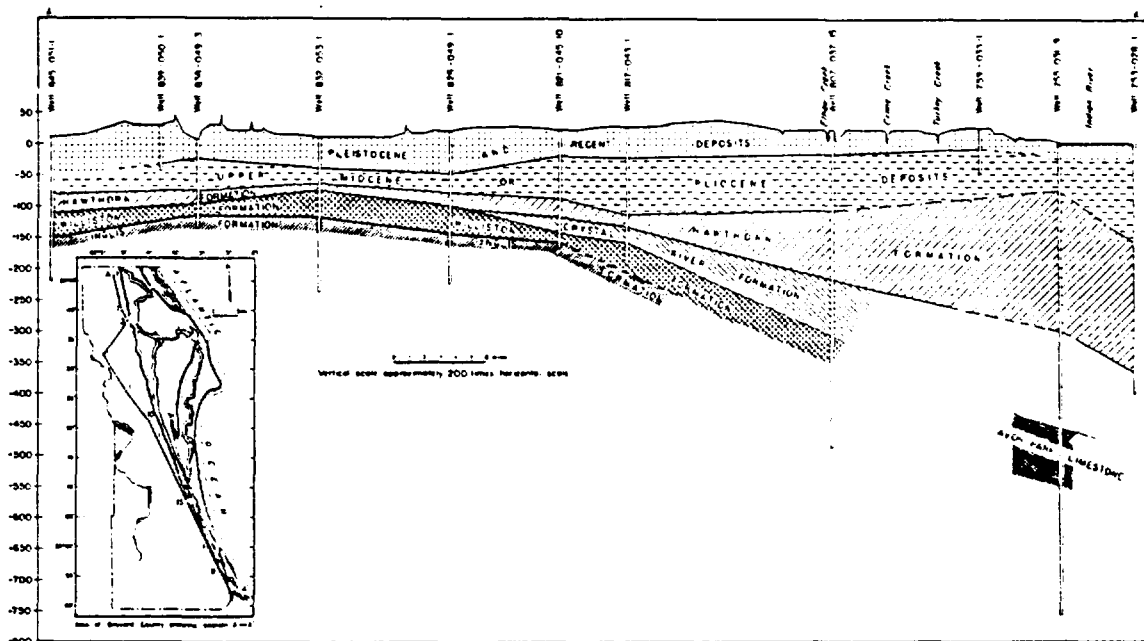
Figure 10. Geologic section A-A'.

Eocene	Ocala Group	Crystal River Formation	0-100	White to cream, friable, porous coquina in a soft, chalky, marine limestone.	Floridan aquifer: Permeability generally very high, yields large quantities of artesian water. Chemical quality of the water varies from one area to another and is the dominant factor controlling utilization. A large percentage of the ground water used in Brevard County is from the artesian aquifer. The Crystal River Formation will produce large quantities of artesian water. The Inglis Formation is expected to yield more than the Williston Formation. Local dense, indurated zones in the lower part of the Avon Park Limestone restrict permeability but in general the formation will yield large quantities of water.
		Williston Formation	10-50	Light cream, soft, granular marine limestone, generally finer grained than the Inglis Formation, highly fossiliferous.	
		Inglis Formation	70 ±	Cream to creamy white, coarse granular limestone, contains abundant echinoid fragments.

Avon Park Limestone		285 ±	White to cream, purple tinted, soft, dense chalky limestone. Localized zones altered to light brown or ashen gray, hard, porous, crystal-line dolomite.

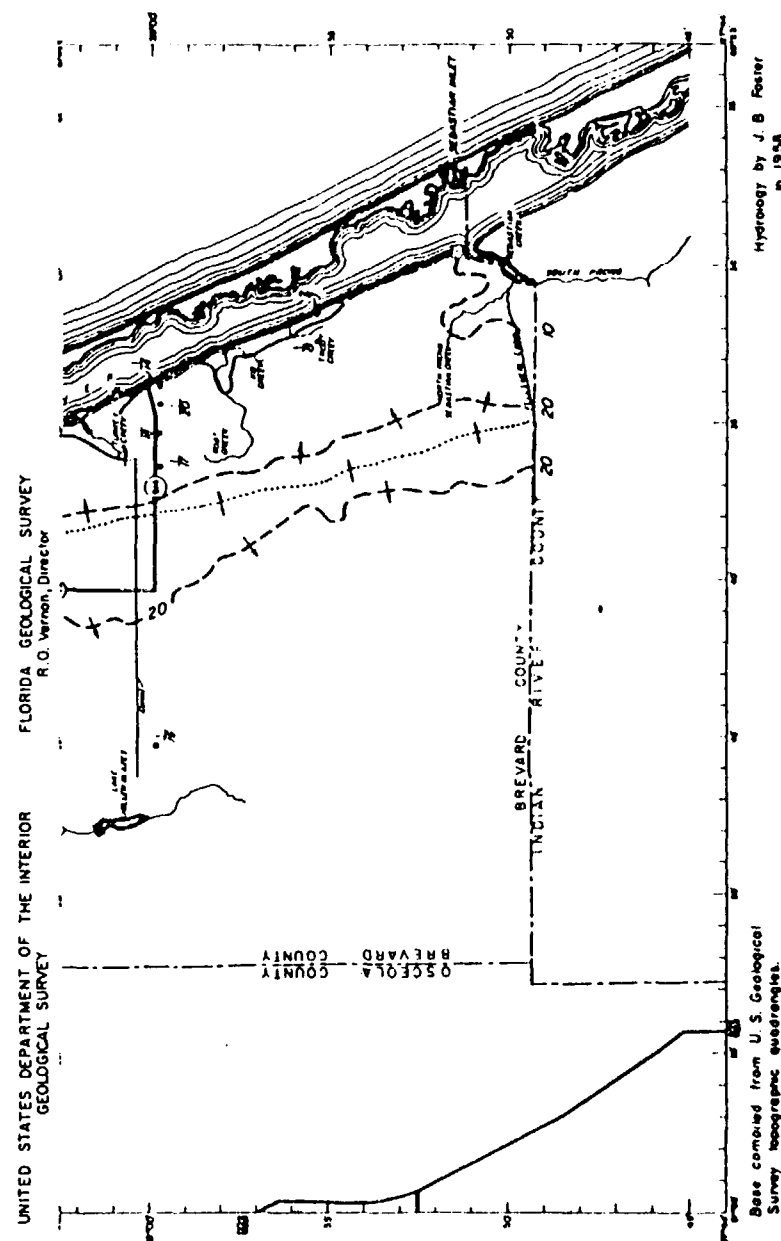
Figure 41. Brevard County showing water-table contours.

The shape and slope of the water table is shown by means of water-table contours on a map of Brevard County (fig. 41). A water-table contour is a line along which all points on the water table have the same altitude. The water-table contours show the configuration of the water table in the same manner that topographic contours show the configuration of the land surface. Although the water table generally has less relief than the land surface, the configuration of the water table generally conforms to the shape of the land surface. Ground water moves downgradient at right angles to the water-table contours; thus, the contours indicate the general direction of ground-water movement, though not the rate. The rate is a function of the hydraulic gradient and the permeability of the sediments through which the water moves.

A ground-water divide is an imaginary line along each side of which the water table slopes downward and away from the line. The ground-water divide is analogous to the land divide between two drainage basins. The ground-water divide in Brevard County is shown in figure 41. This divide line generally follows the topographic high of the Atlantic Coastal Ridge.

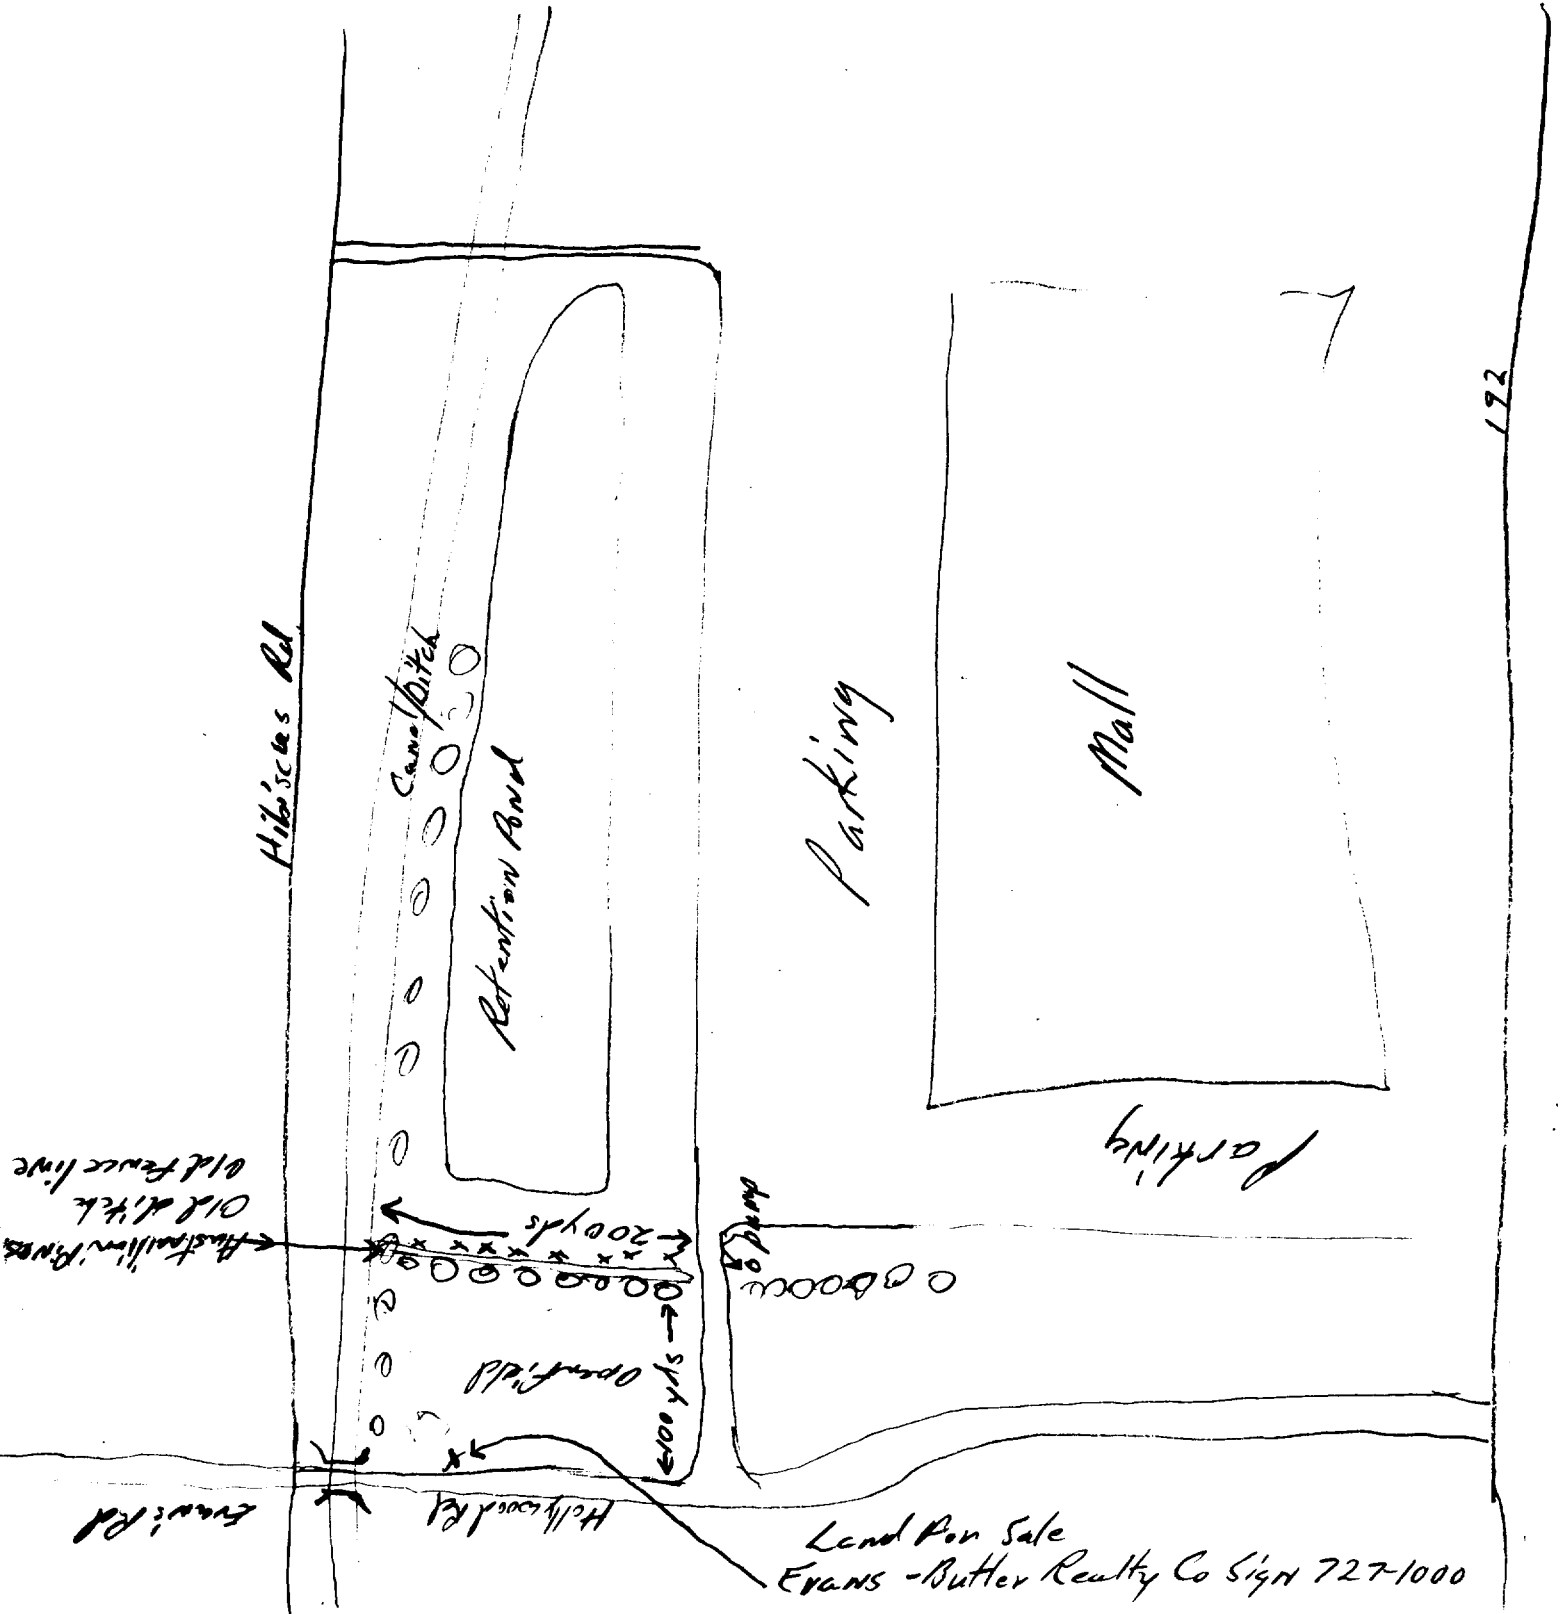
8. Site sketch: (show North on map)

Hibiscus Air  
Gateway Air
